# Attaka 14 Subsea Tree & Wellhead Condition

## Attaka 14 Subsea Well

Water Depth : 182'

Wellhead : 18-3/4" SG-5, 10,000 psi Vetco Gray Wellhead

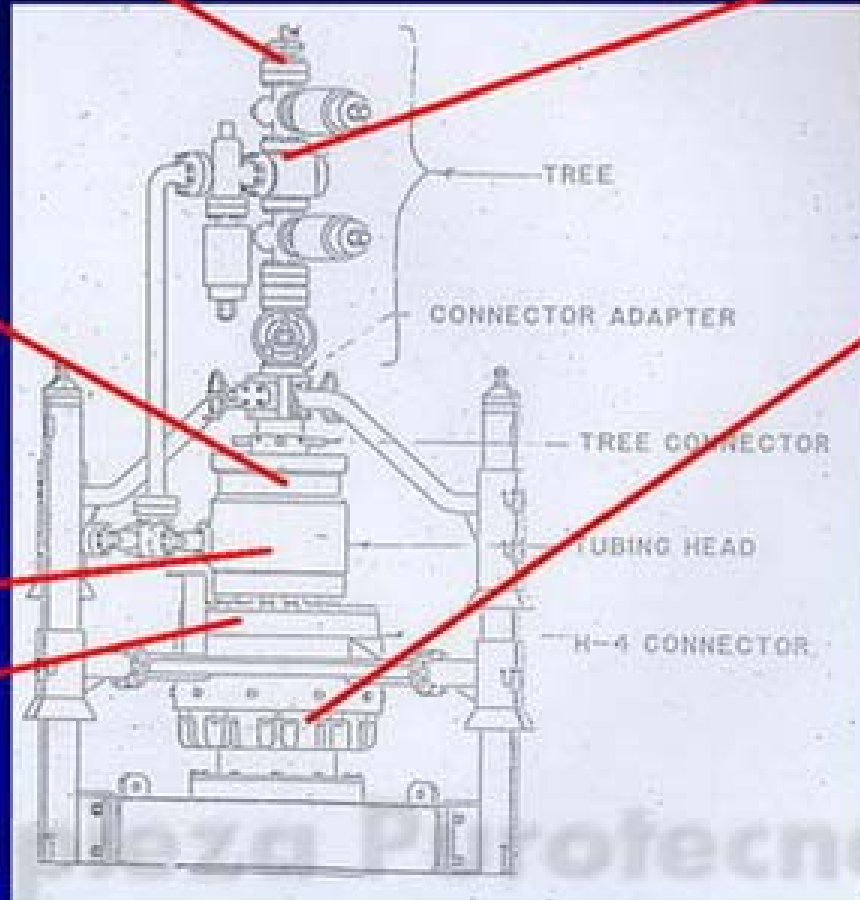
Tree cap seems OK. No leak seen.  
Just covered by marine growth

Subsea tree-Tubing head connector  
seems OK. No leak seen. Just covered  
by marine growth

Tubing head seems OK. No leak seen.  
Top section of H connector seems OK  
as well, no leak

Subsea tree seems OK. No leak seen.  
Just covered by marine growth

Bottom part of H Connector cannot be  
seen clearly, but seems no leak

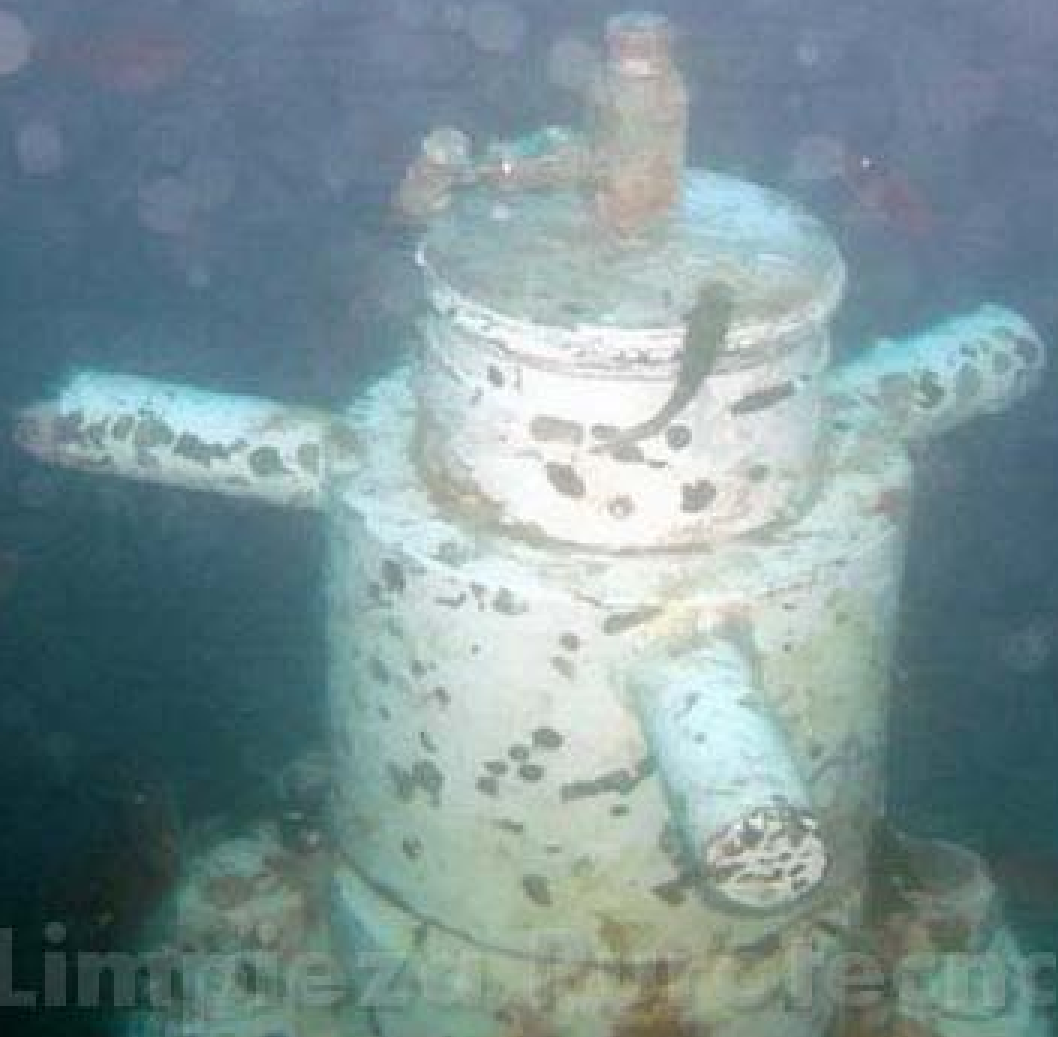
Tree cap adapter  
after cleaning

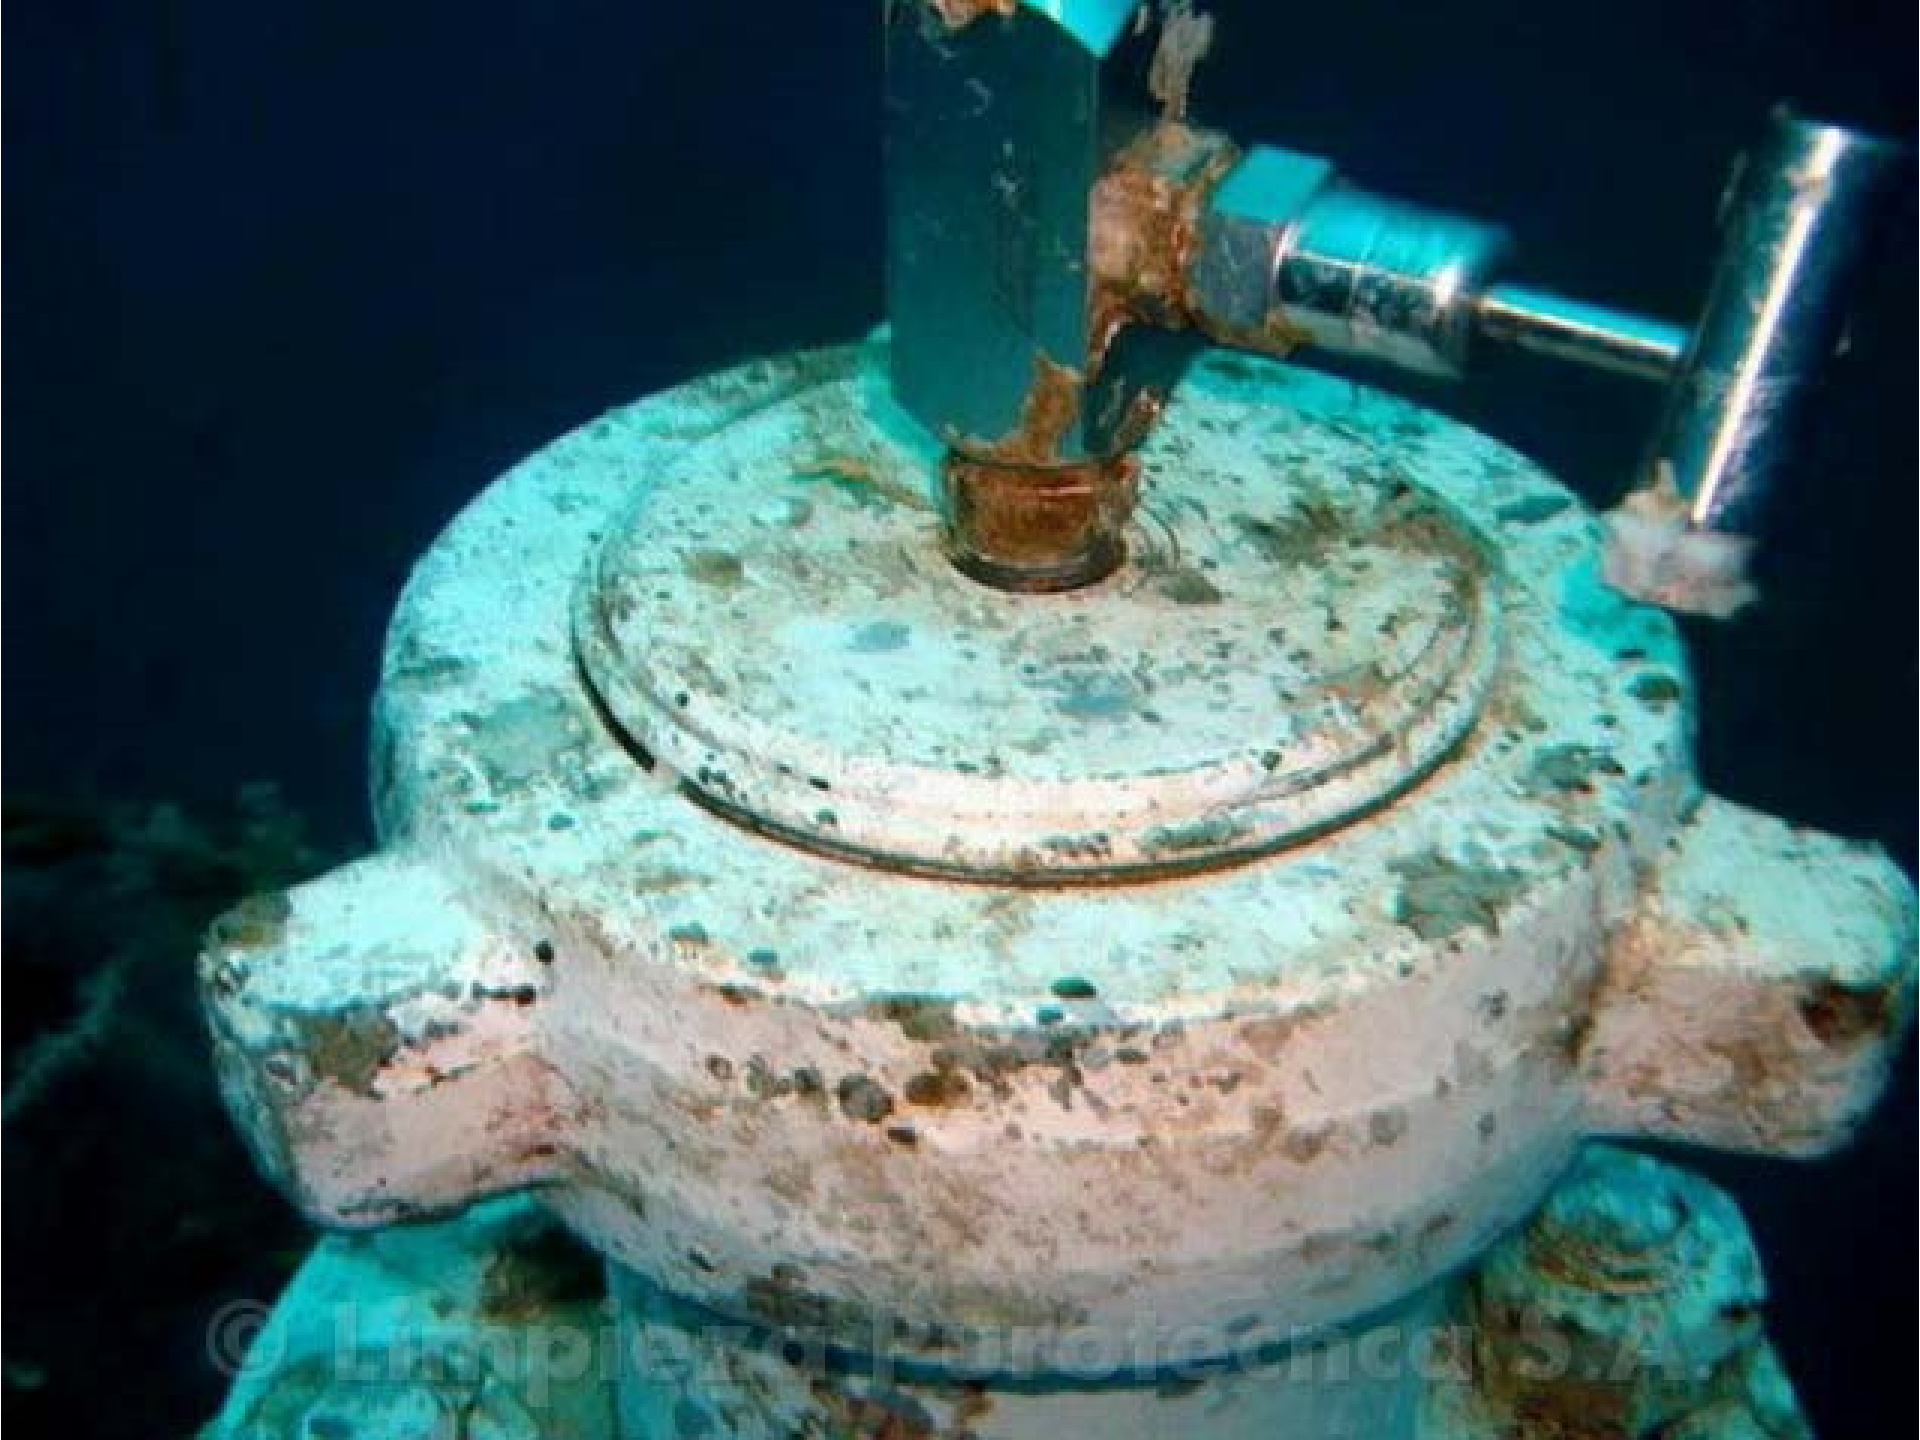
Tree cap adapter  
covered by thick  
marine growth  
both hard & soft

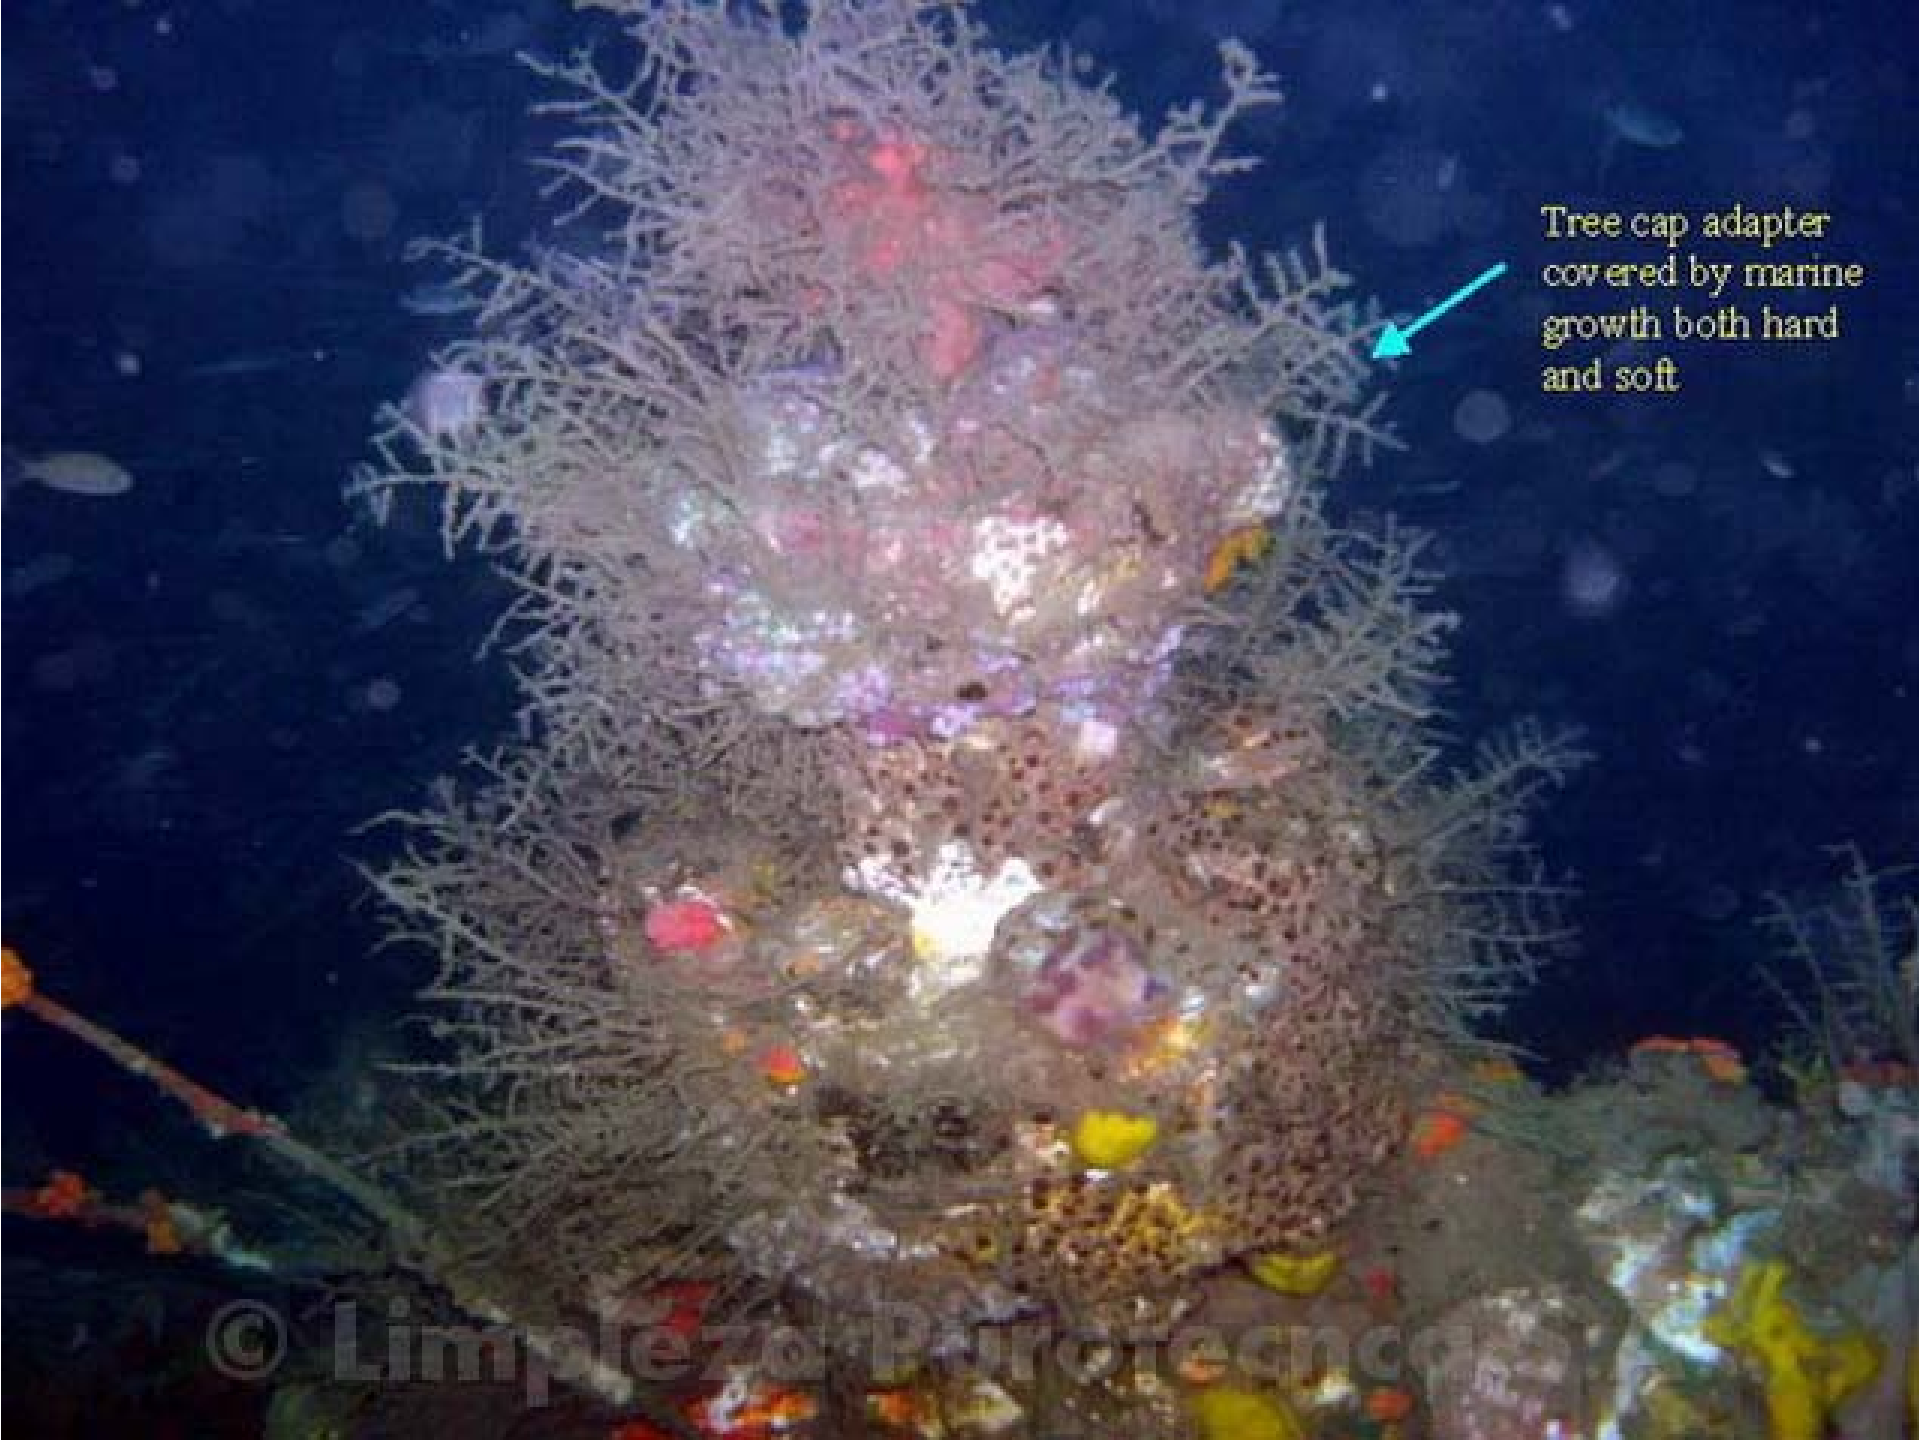
Tree cap adapter covered by marine growth both hard and soft

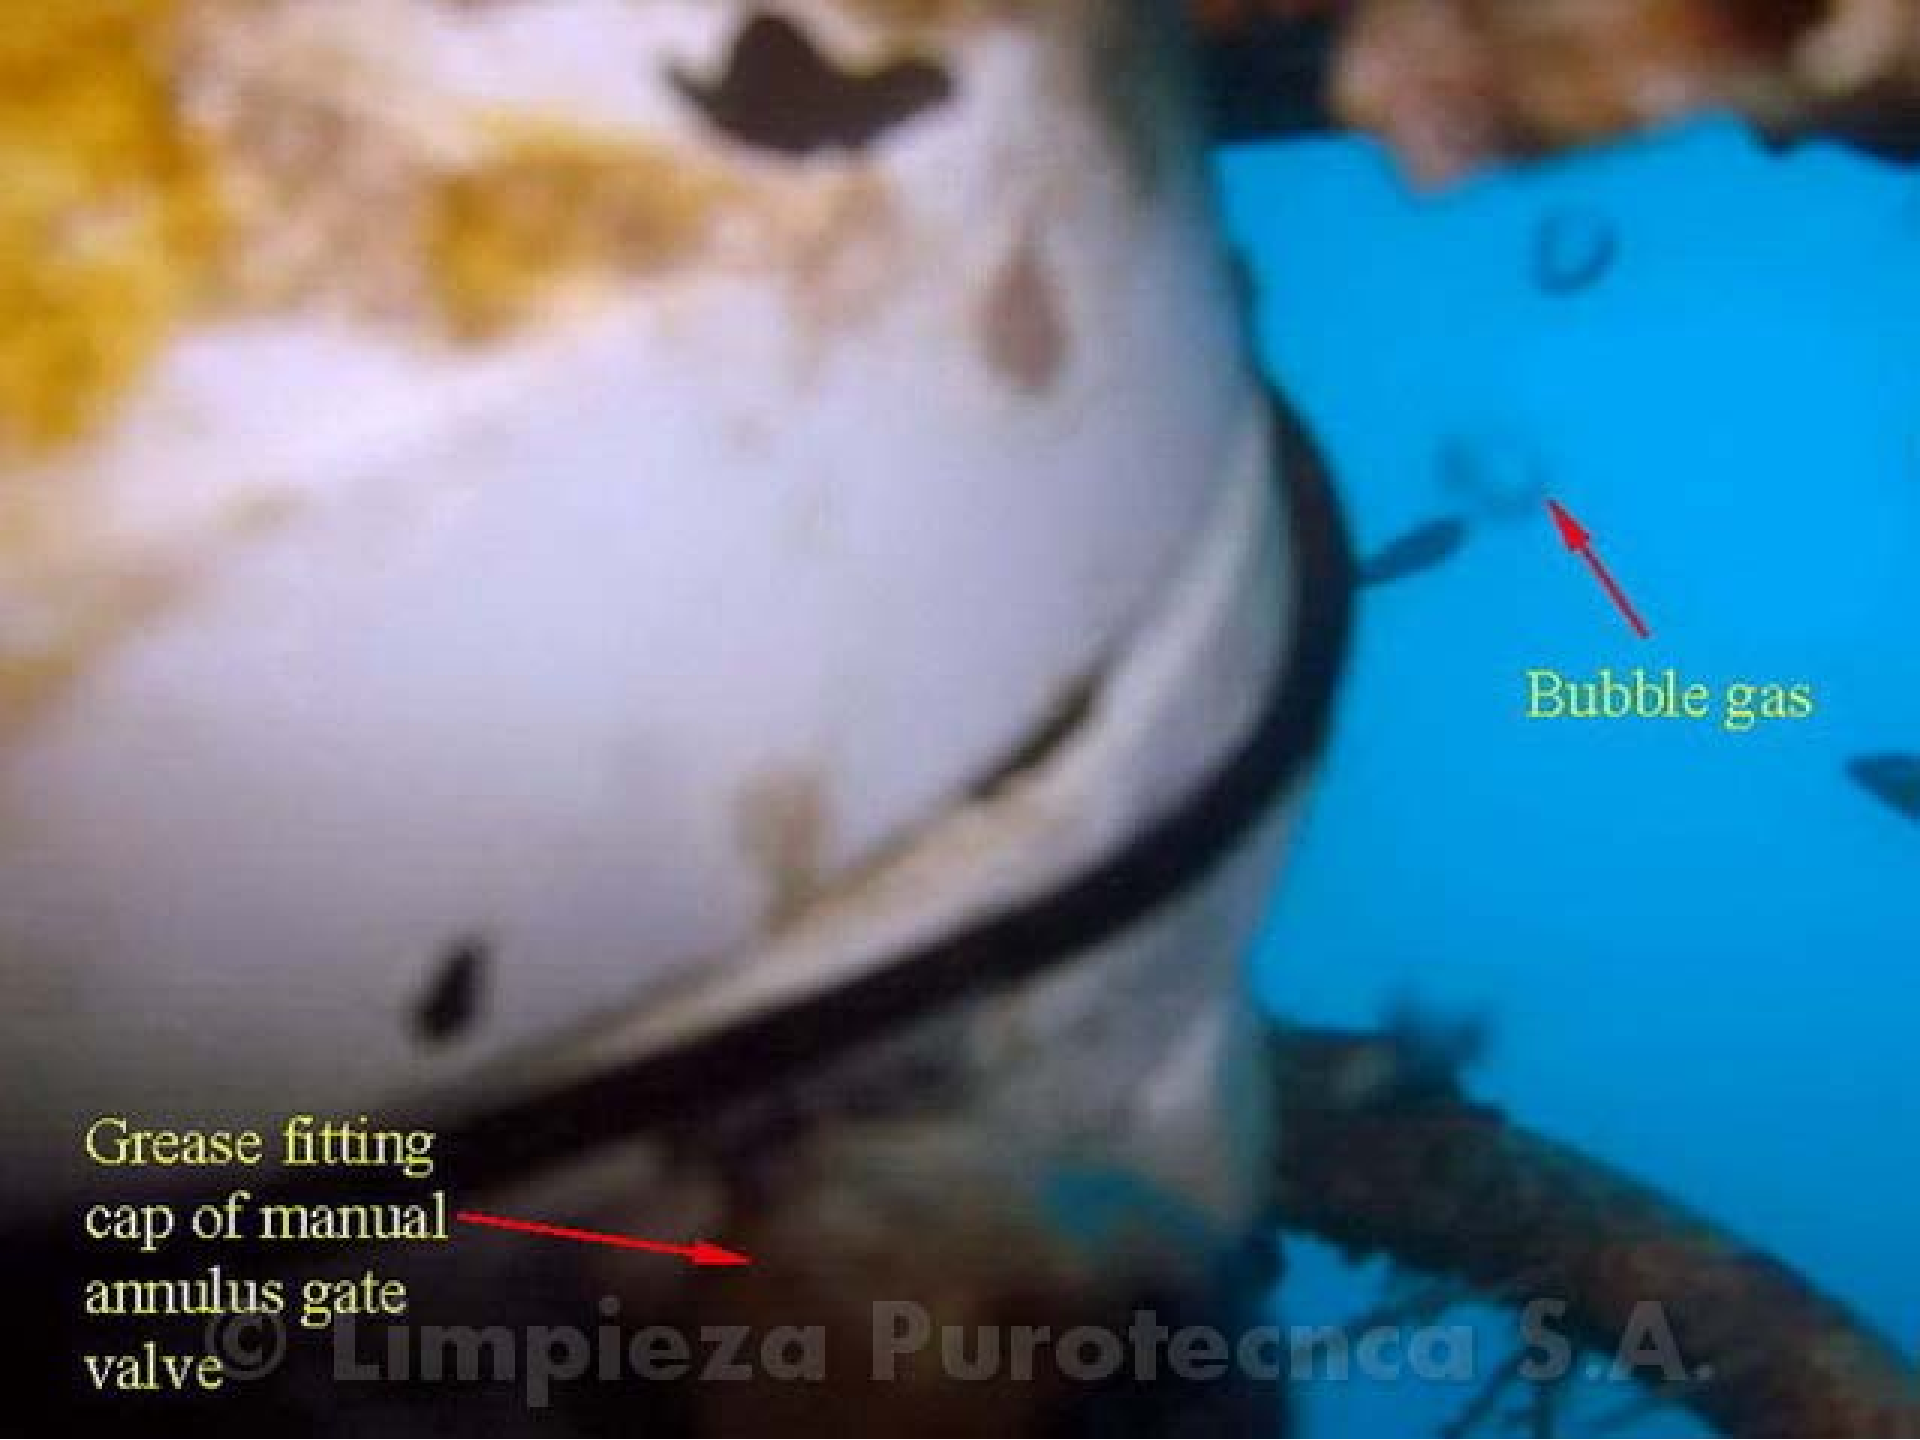
Bubble gas

Grease fitting  
cap of manual  
annulus gate  
valve

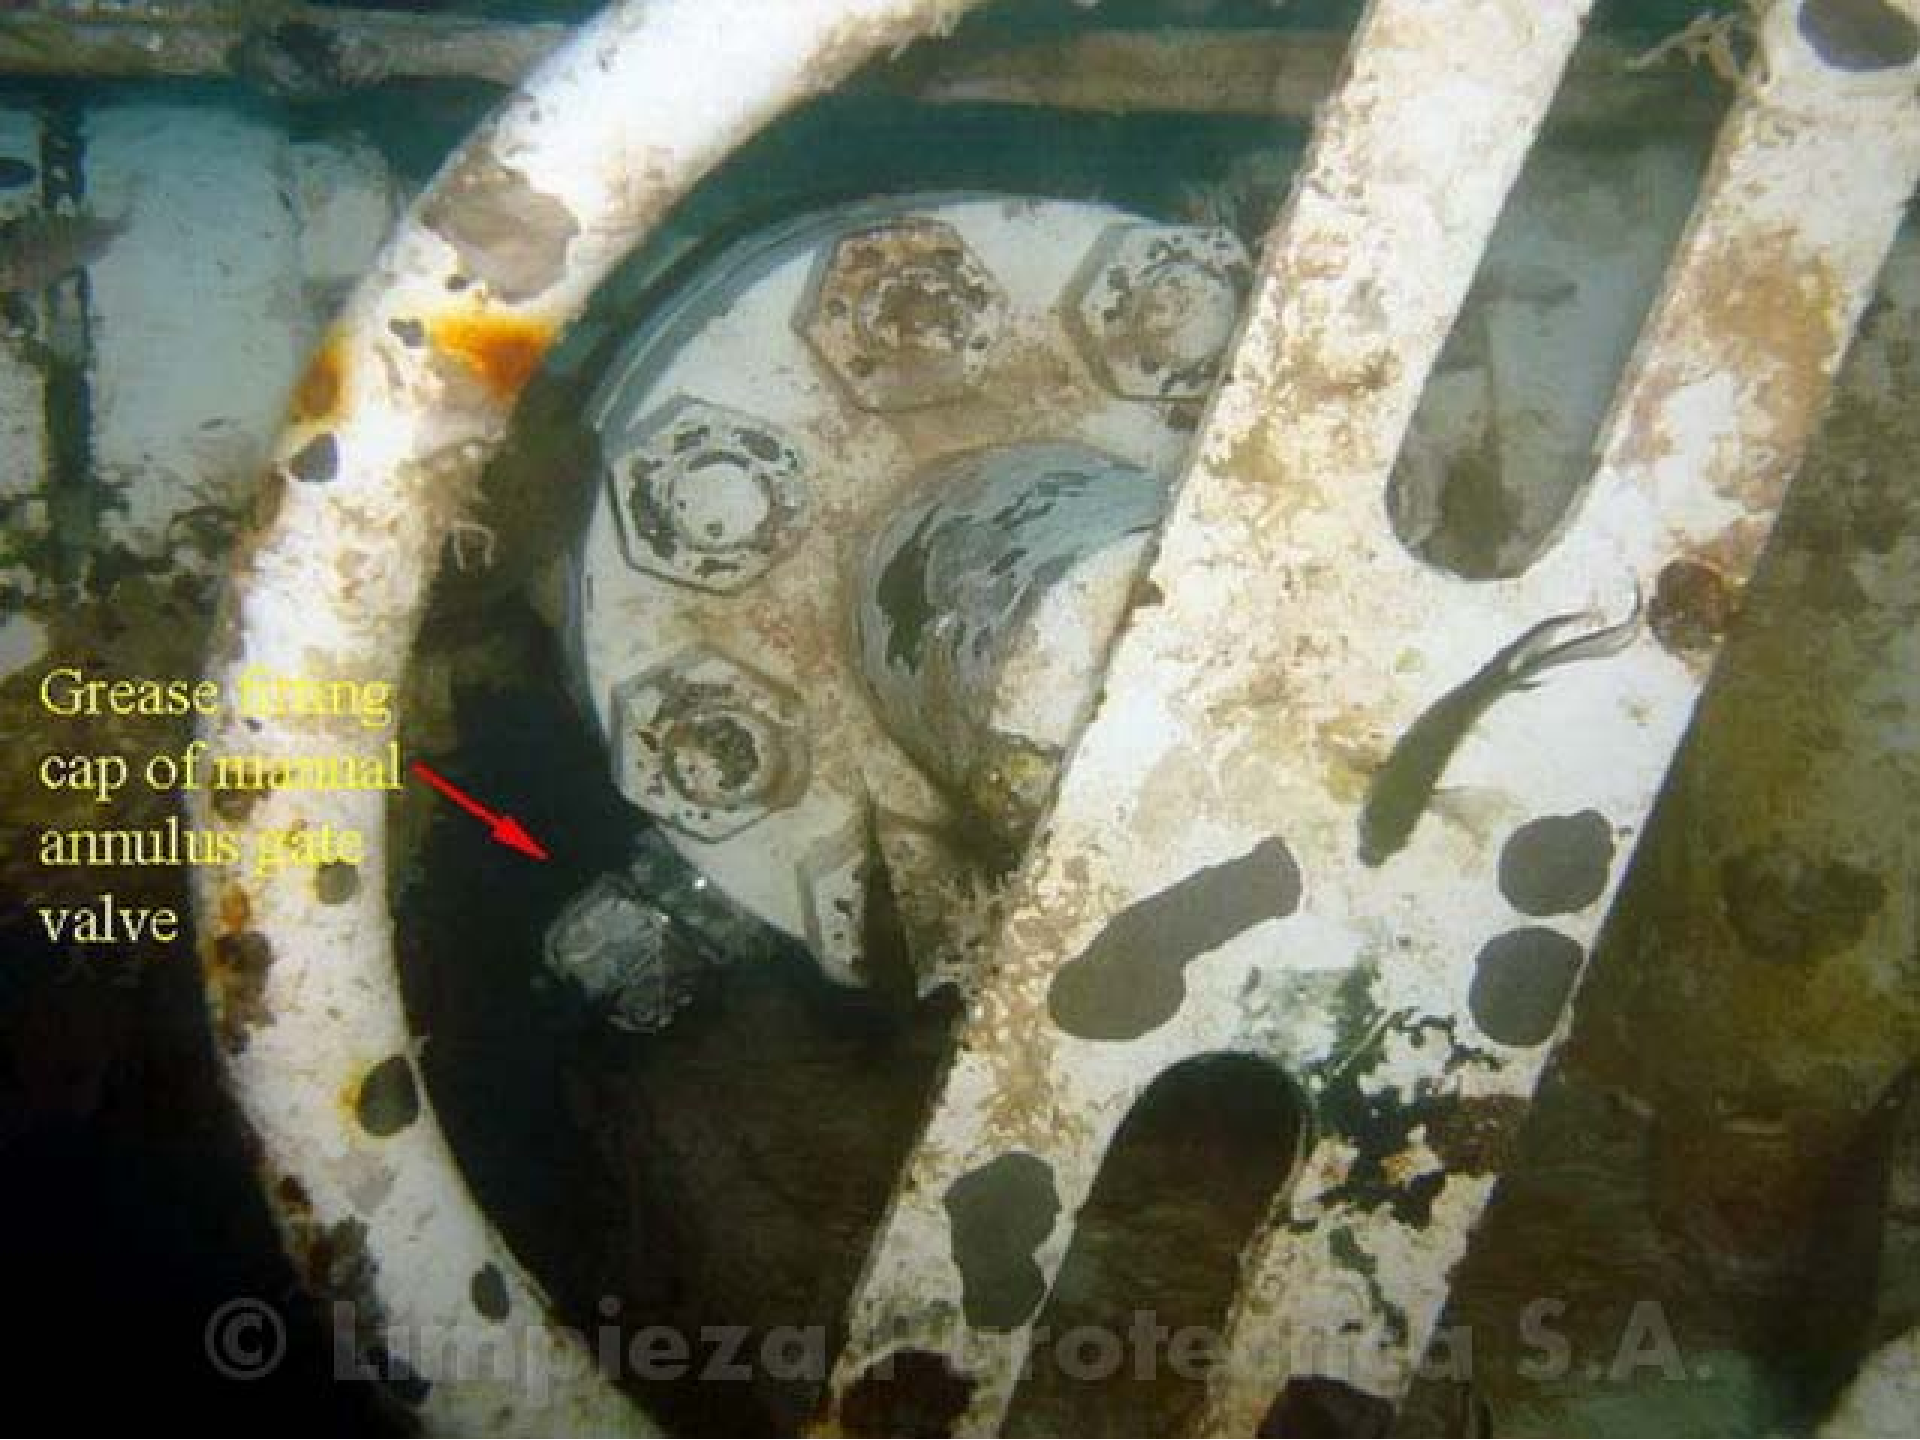
Grease fitting  
cap of manual  
annulus gate  
valve

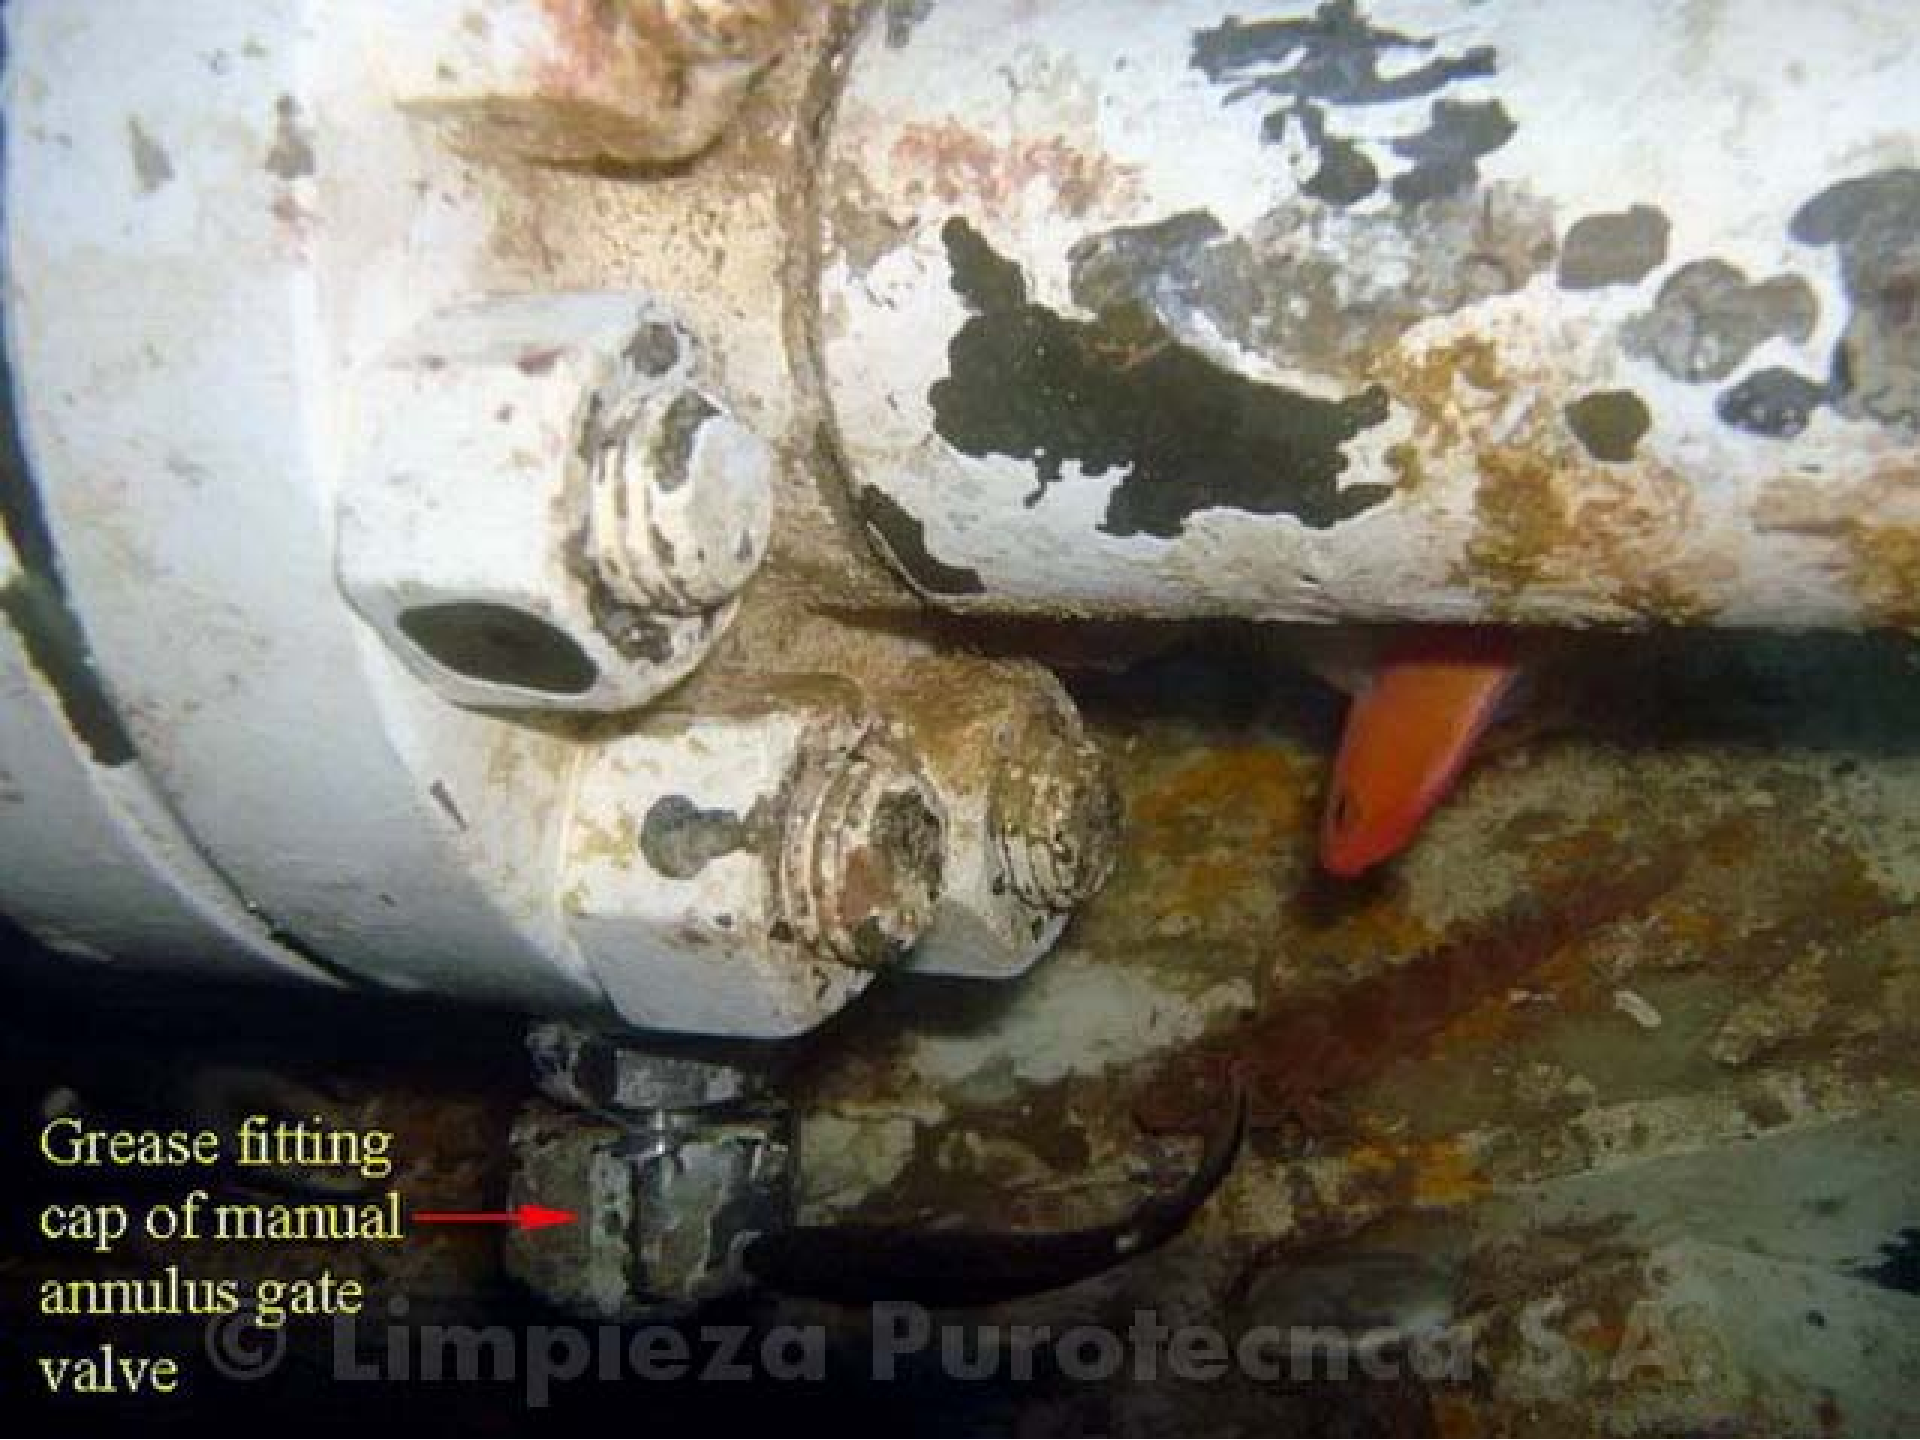
Grease fitting  
cap of manual  
annulus gate  
valve
